**LOWER GUADALUPE RIVER FLOOD
CONTROL PROJECT – POND A8W
SANTA CLARA COUNTY, CALIFORNIA
IDENTIFICATION OF WATERS OF THE U.S.
ADDENDUM “A” TO CORPS FILE NUMBER 24897S**

H. T. HARVEY & ASSOCIATES

April 9, 2002

Project No. 1130-02

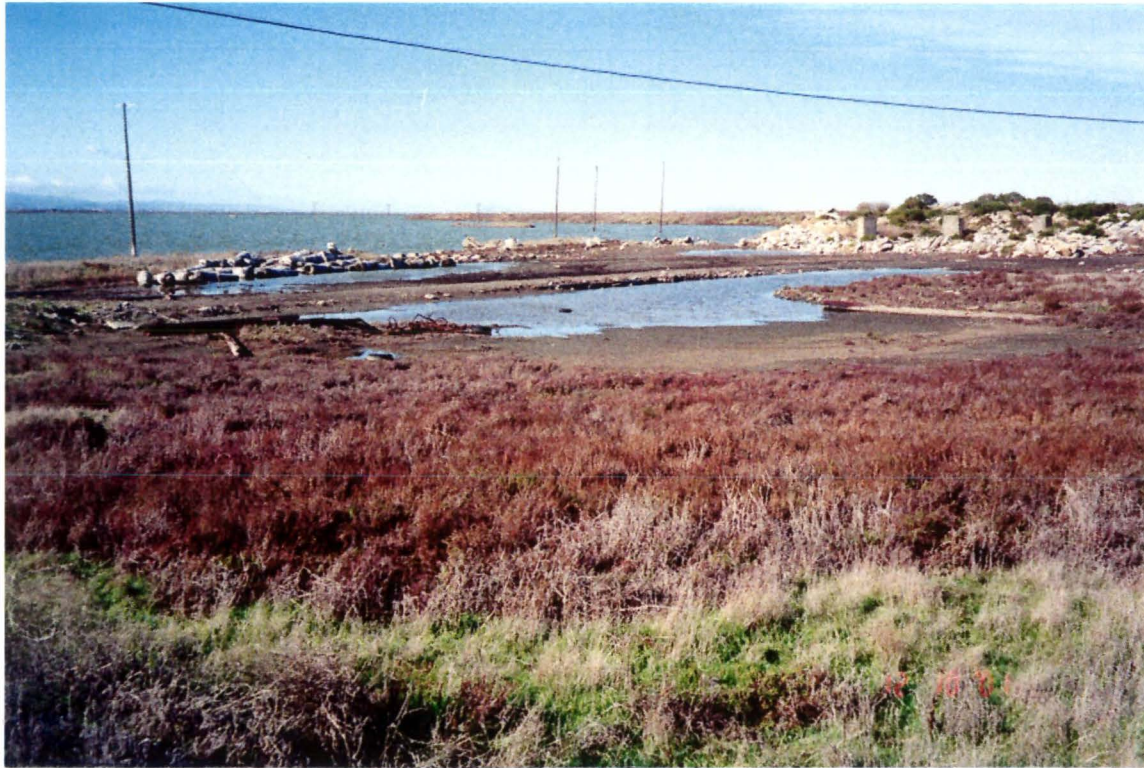
launch activities, dwellings, and more recently as a dump for construction materials (Photograph 1; Appendix D).

- An isolated, dense stand of common pickleweed (*Salicornia virginica*; OBL) is located along the eastern edge of the potential Section 404 other water (Photograph 1; Appendix D). Indicators of hydric soils and wetland hydrology were also observed (Sample Point 1; Appendix C). Therefore, this common pickleweed stand is identified as a potential Section 404 wetland in Figure 5.

Photograph 1: Northern portion of project site depicting broad, depressional area that supports isolated ponding and a dense pickleweed area. Note large dumping area of construction debris in background.

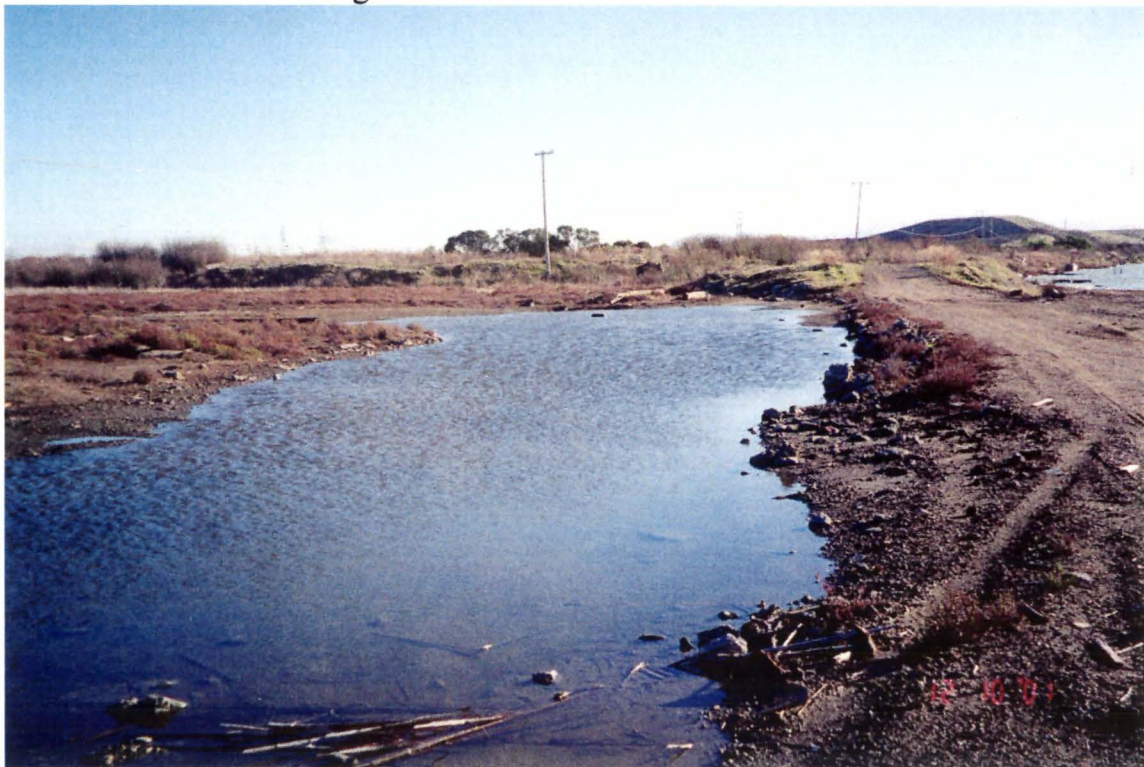
Photograph 2: Ponded conditions within northern depressional area; view is to the south. This area is described as a Section 404 other water.

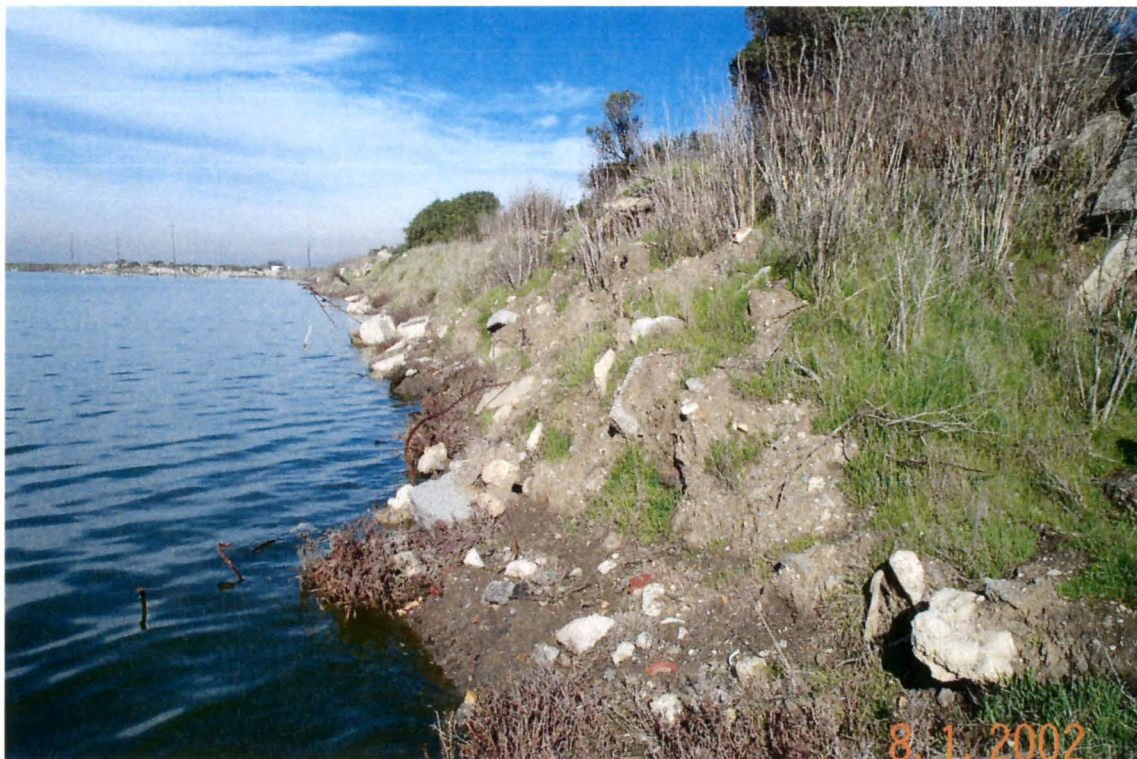
- The levee separating Alviso Slough from Pond A8W has a relatively steep bank that is shored up with substantial amounts of concrete debris (Photograph 3; Appendix D). Located along the toe of this levee are scattered, narrow bands of common pickleweed that are directly supported by the water from Pond A8W (Photographs 4 and 5; Appendix D). Therefore, an aquatic moisture regime was assumed. These stands of common pickleweed are located behind a levee and presently occur at or below MHW as determined by projecting the MHW mark along Alviso Slough back to the area in question. Based upon review of historical sources, these areas historically occurred below MHW as well (Figure 5). Therefore, these stands of common pickleweed are considered to be potential, historic Section 10 wetlands.

Photograph 3: Southeastern perimeter of Pond A8W; view is to the north. Note the abundance of concrete debris along the levee.

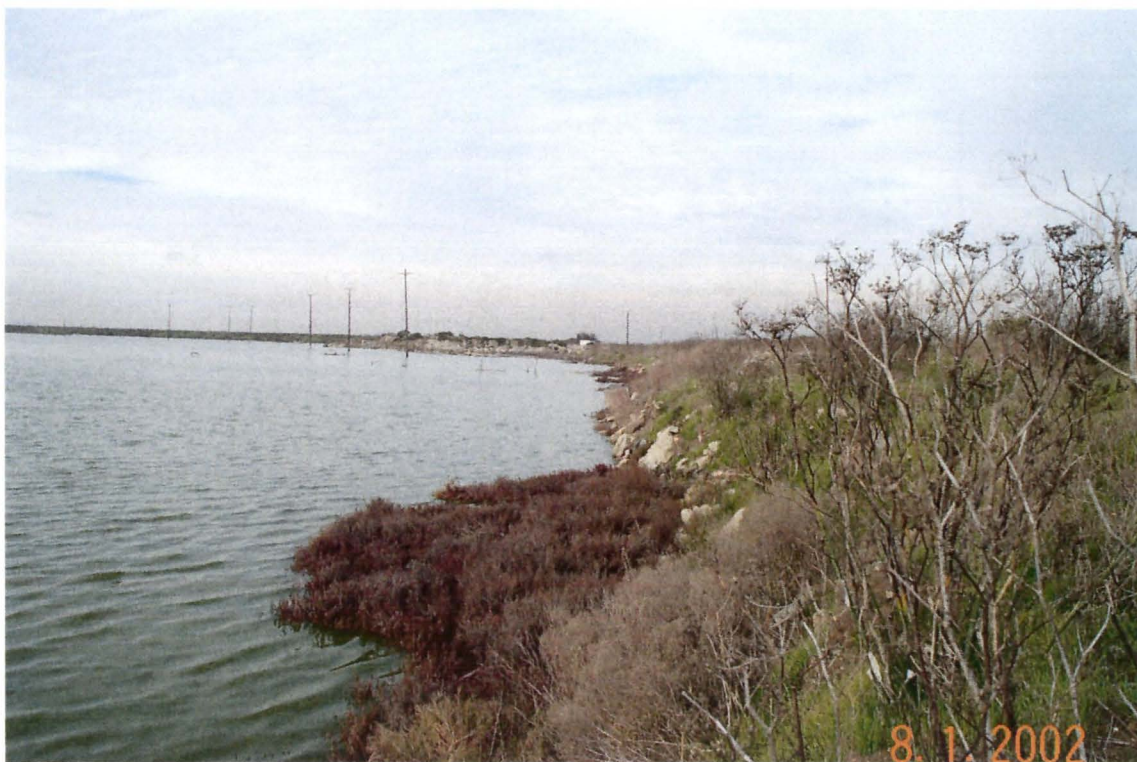
Photograph 4: Example of pickleweed dominated wetland located along the toe of the levee.

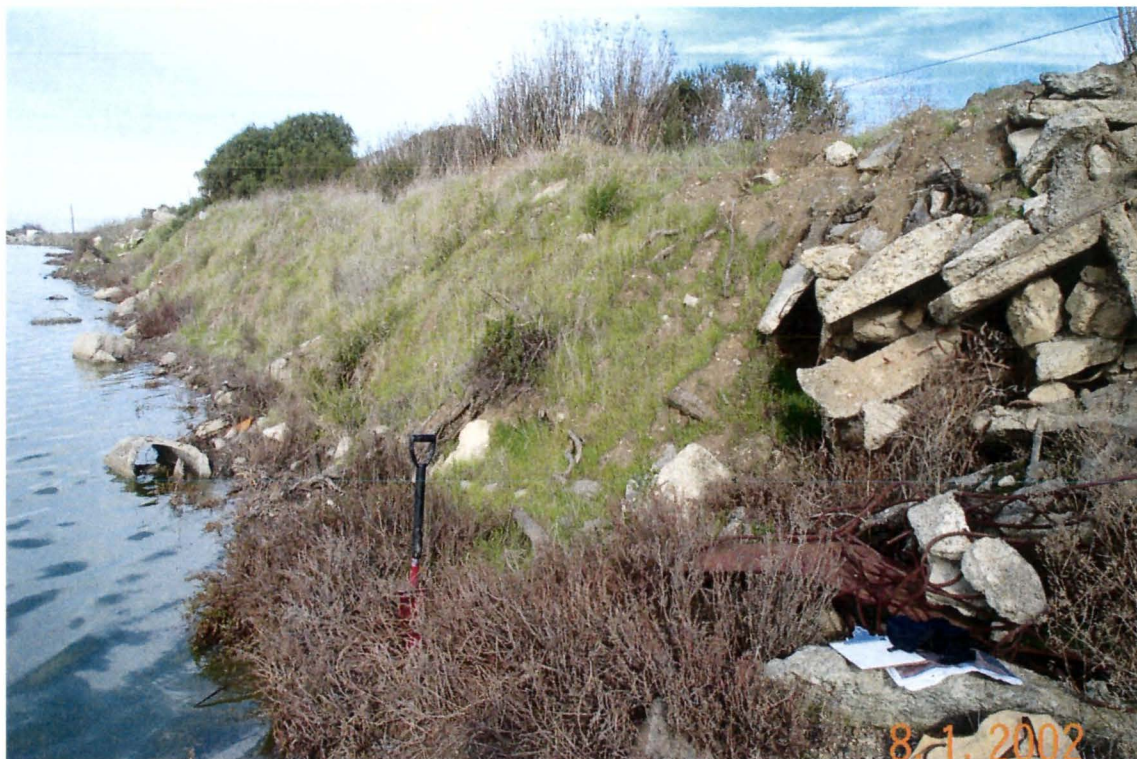
Photograph 5: Example of a narrow band of pickleweed wetland along the toe of the levee. Note the steepness of the levee bank which limits the width of the wetland.

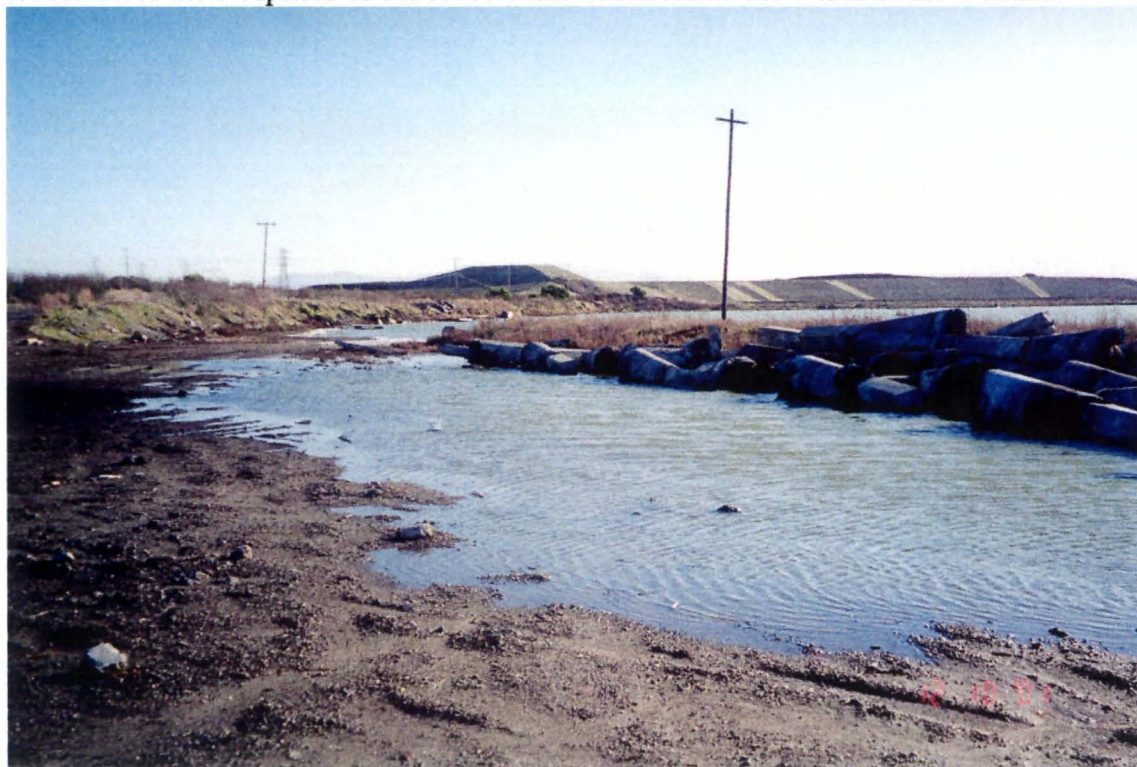
Photograph 6: Section 404 and Section Historic 10 other water directly linked to Pond A8W. A very shallow shelf, depicting the OHW mark, occurs at the limit of the water's edge.

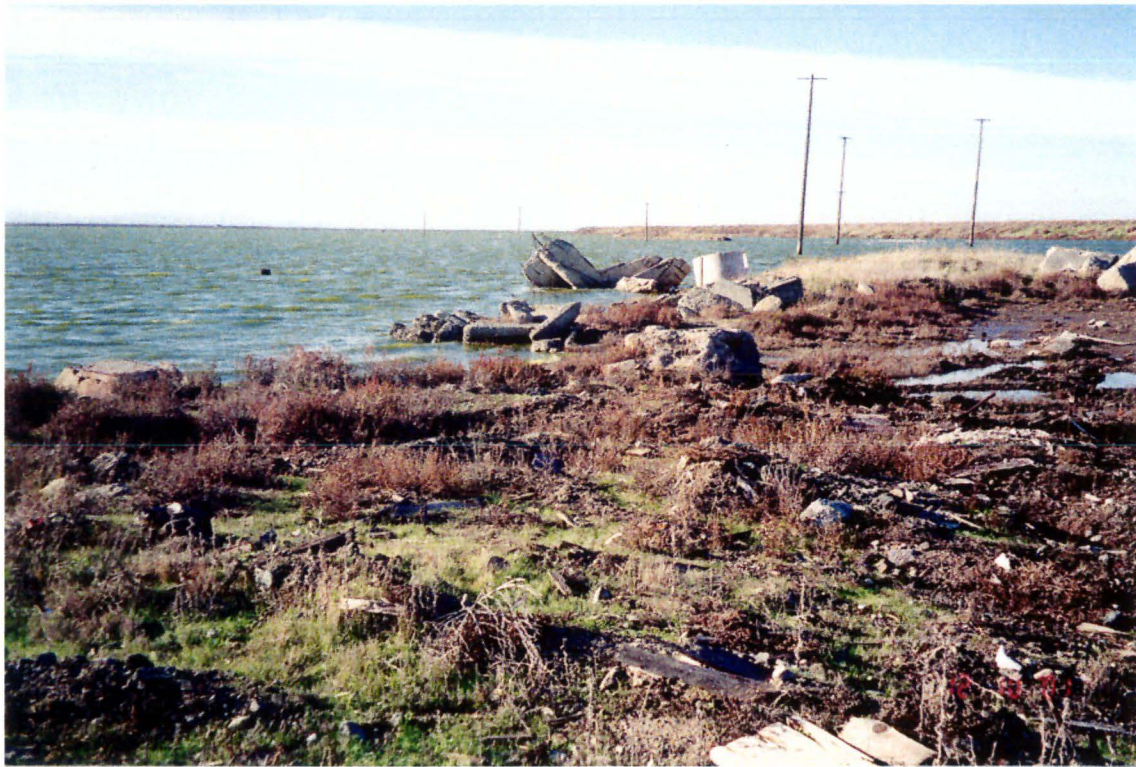
Photograph 7: Example of an area described as an upland due to the lack of hydric soil and wetland hydrology features. The scattered pickleweed plants are present due to the relatively high salinity within the soils.
